# From fixing to learning

- learning from incidents and inspiring proposed improvements

# **Nobles Incident Investigation process**

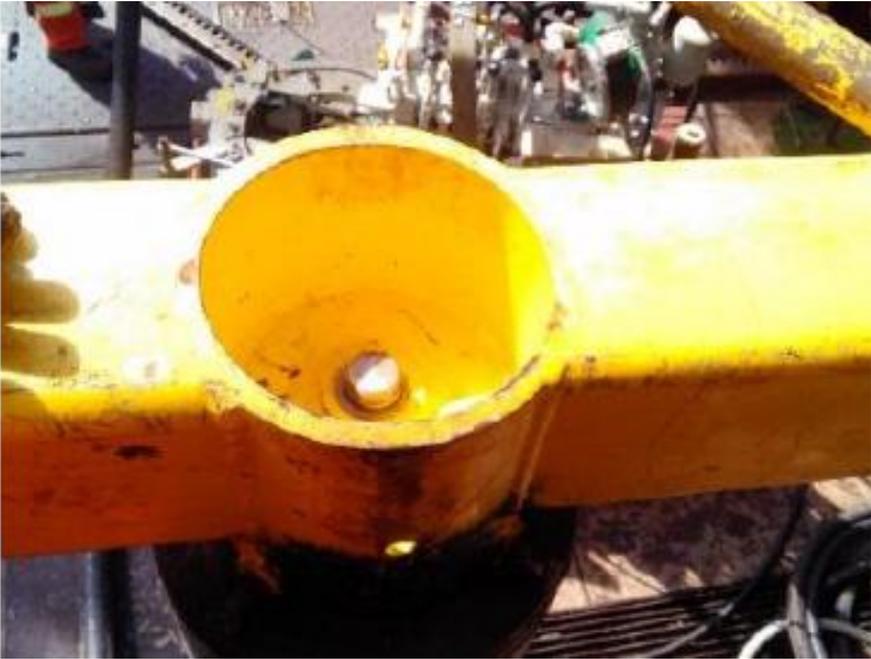
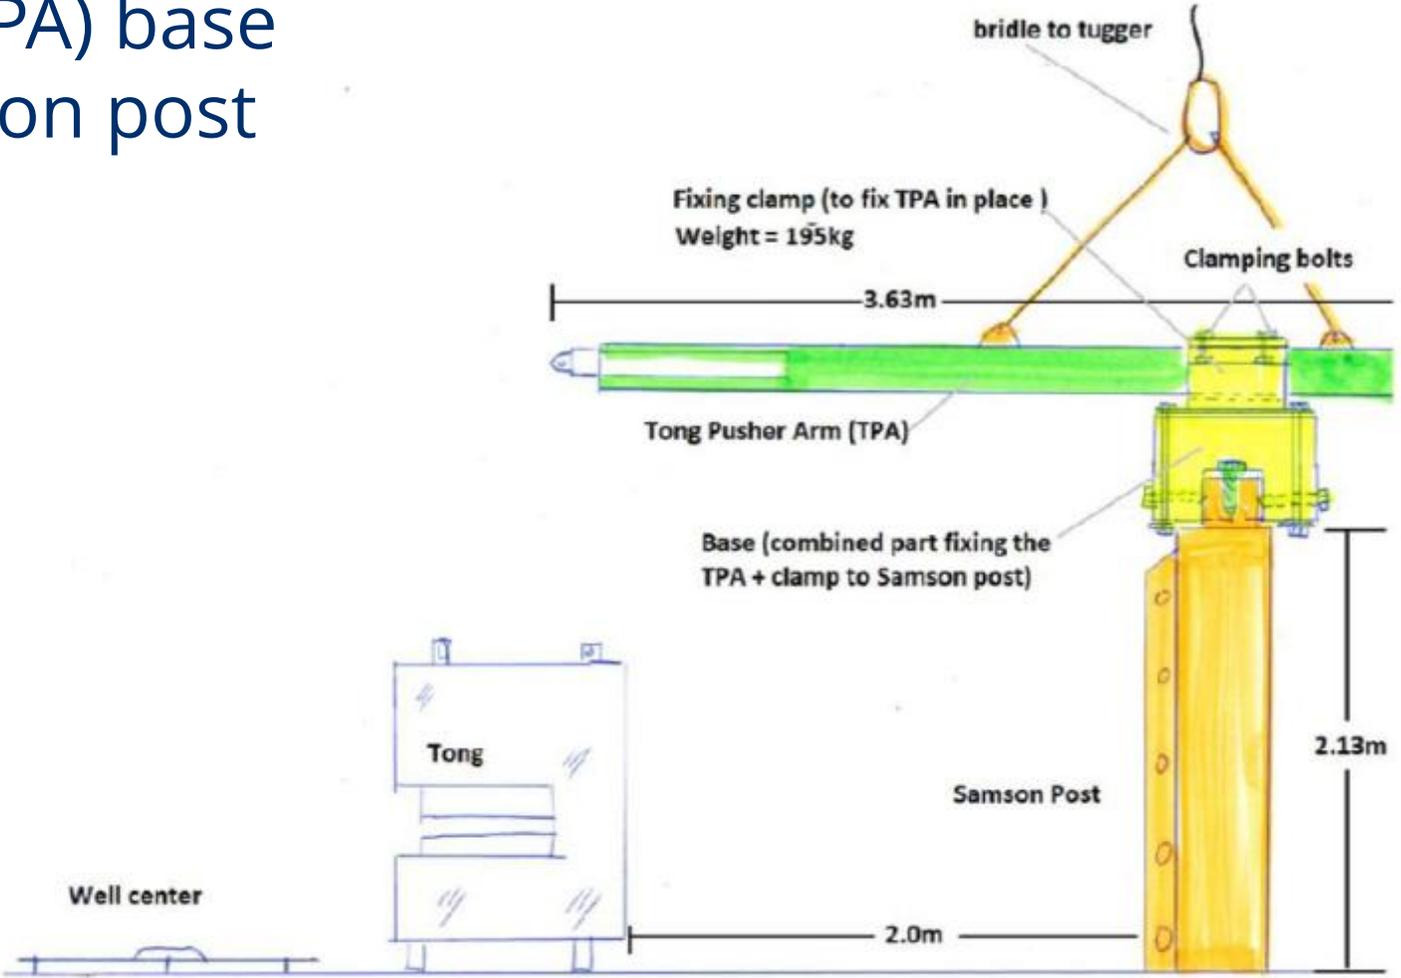
# Case 1: Tong push arm (TPA) base plate dropped from samson post

Tong pusher base plate situated on top of samson post came loose and fell to the rig floor when the extension cylinder grip was being adjusted.

Being investigated, but it appears that an incorrect size bolt was installed to secure the base plate to the samson post

Check securing mechanism for base plate before taking the system into use again.

All rigs to check if similar system is installed and check the securing bolt.

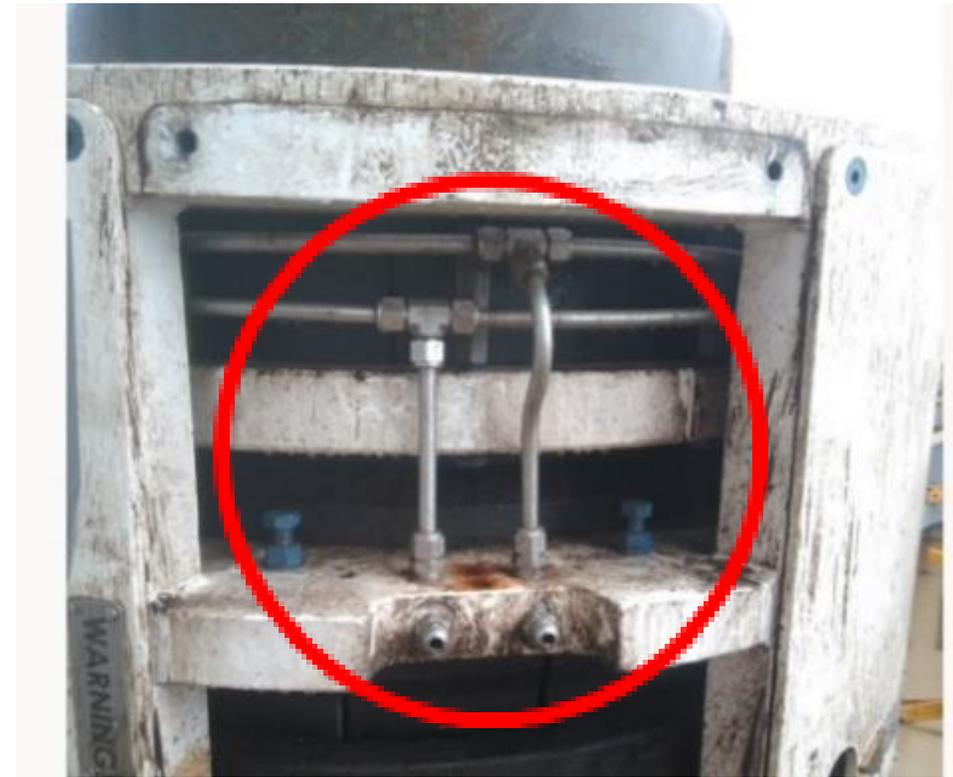
Photo from Tj showing the reversed tubing

TJ #1	TJ #2
Manual (Drawing)	Left N12 = lock Right N13 = unlock	Left N12 = lock Right N13 = unlock
Physical piping	Left= unlock Right = lock	Left = unlock Right = lock
Plate label	Left = N12 Right = N13	N/A
Painted label	N/A	After the incident Left = unlock Right = lock
