# From fixing to learning

- learning from incidents and inspiring proposed improvements

# **Nobles Incident Investigation process**

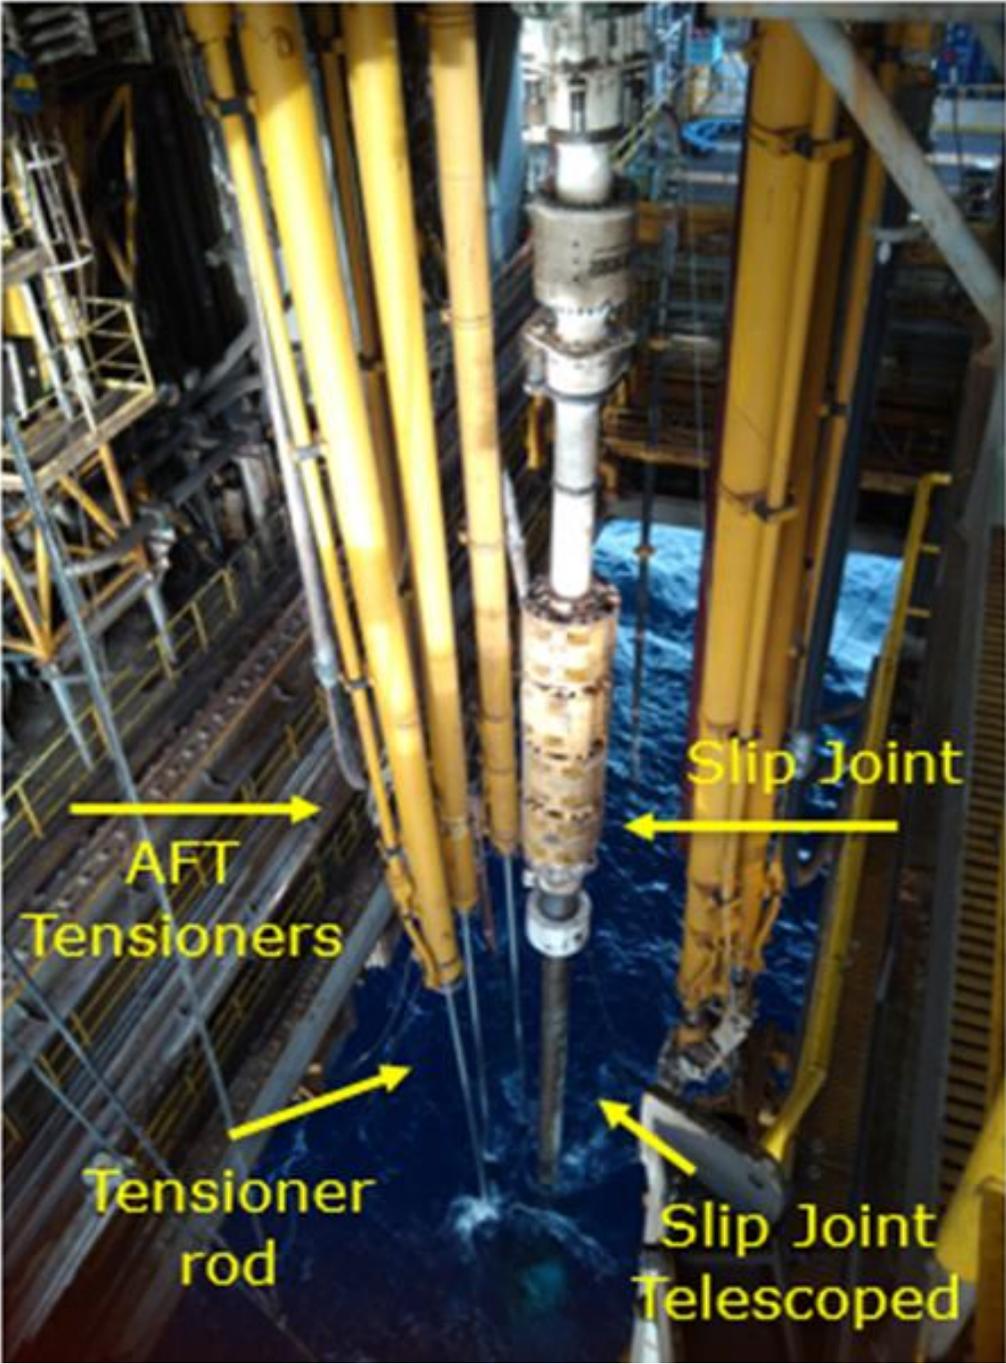
# Example 2: Unintended release of Telescopic Joint

AFT Tensioners

Slip Joint

Tensioner rod

Slip Joint Telescoped

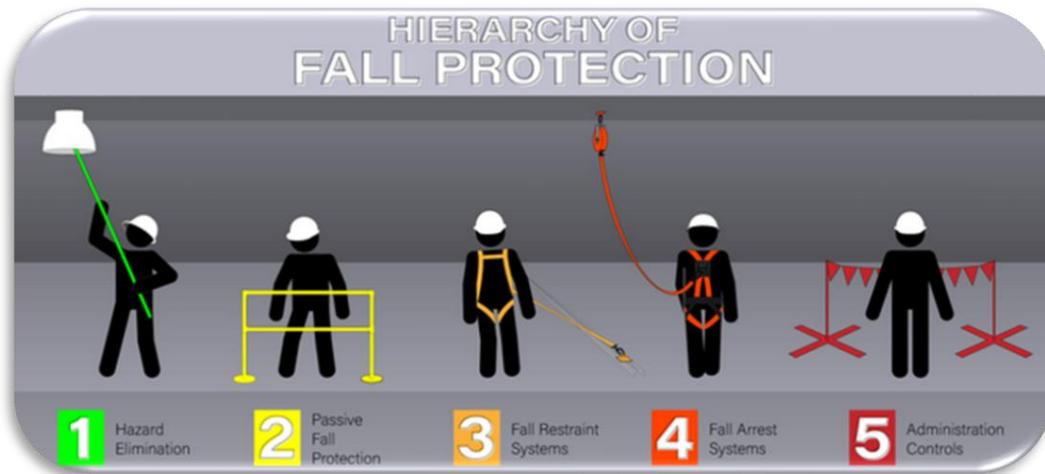
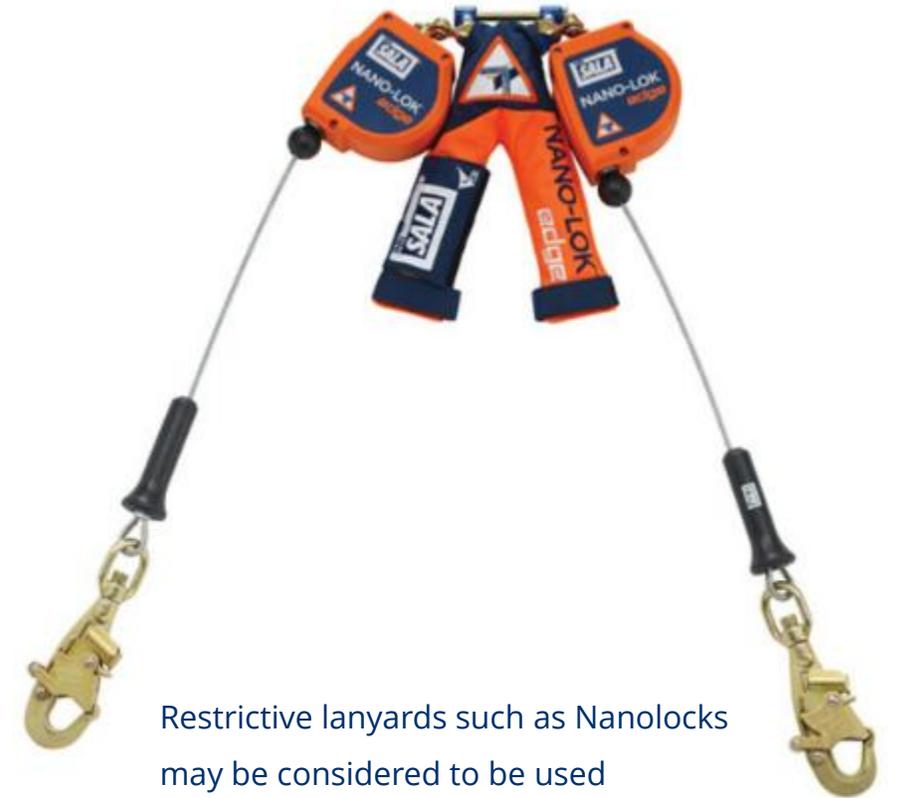
Restrictive lanyards such as Nanolocks may be considered to be used

*Working at height lanyards that restrict falls may be used at all Noble locations. When there is the possibility of falling, only lanyards equipped with a shock absorber(s) shall be utilized at Noble locations*
